## PROPERTY INSPECTION REPORT

**Concerning:** 100 Myhome Drive, Beautiful, Texas  
(Address or Other Identification of Inspected Property)

**By:** Steven R. Cook, TREC 8713 2-1-2009  
(Name and License Number of Inspector) (Date)

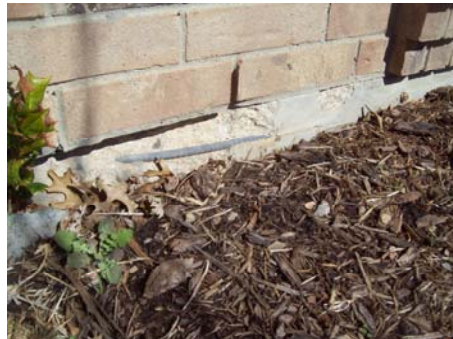
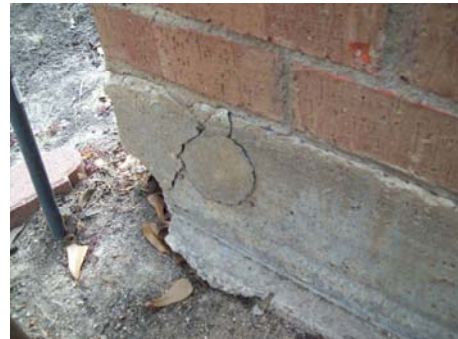
- Exposed steel observed at the front left corner should be protected to prevent rusting.
- Corner "pops" or cracks noted at one or more corners, including the back left. These are usually caused by the differential drying and/or expansion of the concrete and brick at the corner and are not a structural concern unless enough of the corner breaks out that the brick is no longer supported. Recommend monitoring.

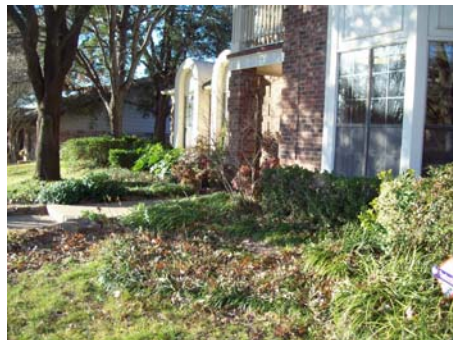
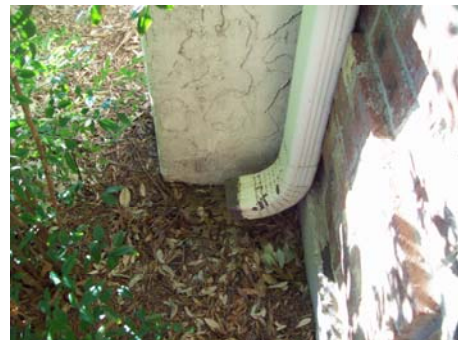
- Observed what appears to be some poor drainage along the back porch from the pool deck area. This may lead to water on or around the back porch.
- The gutters are full of leaves and debris and require cleaning to avoid spilling roof runoff around the building – a potential source of water entry or water damage.
- One or more splash blocks is/are missing, missing splash blocks allow the runoff to create a depression that will hold water; recommend replacing.
- The downspouts discharge water close to the house. Downspout should discharge water at least five (5) feet from the house. Storm water should be encouraged to flow away from the building at the point of discharge.

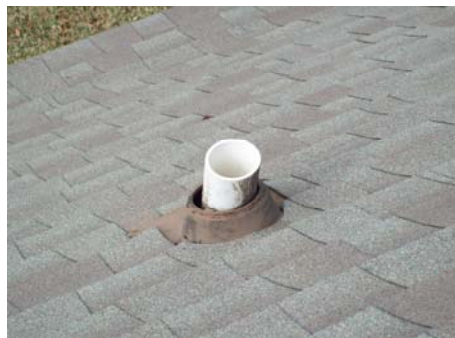
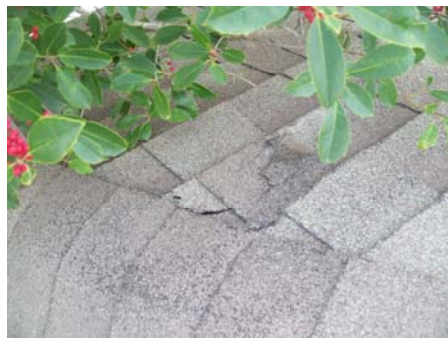
- Noted areas of damaged shingles, apparently caused by overhanging tree limbs. Recommend repairing the damaged shingles and trimming the trees back away from the roof.
- Nails popping through roofing or exposed at the back middle; recommend resealing to prevent water penetration.
- Torn and damaged vent boots including the one on the right side of the house. Suggest further review by reputable roofing company and repair.

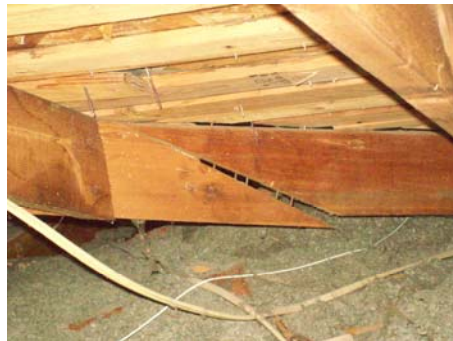
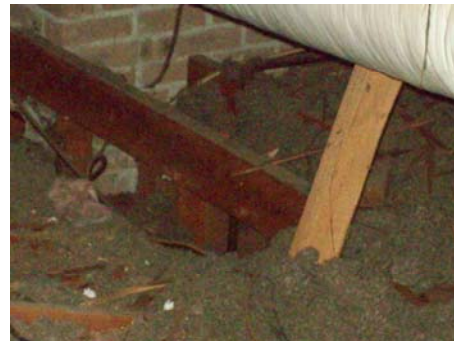
- Observed some separation at a rafter joint at the front middle of the attic area; recommend repair.
- Observed a crack along a rafter at the back of the house, possibly caused by the drying of the wood; recommend repair.
- Firestopping was not present in the attic surrounding the chimney flue.

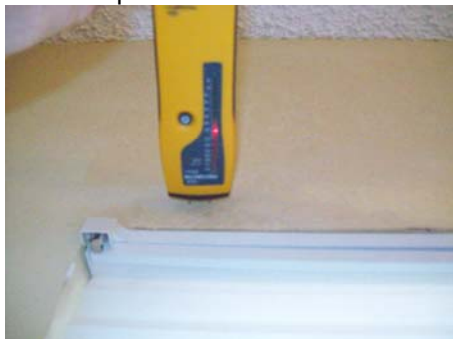
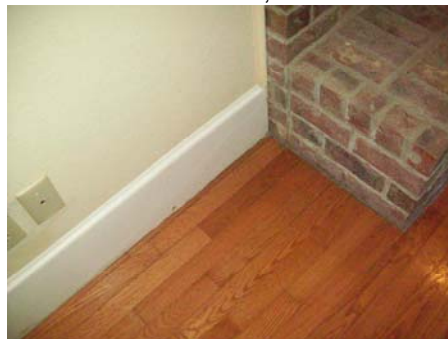
- The area above the dining room window has a water stain and shows an elevated moisture content; any damaged materials should be removed and replaced and the cause for the moisture repaired to prevent additional deterioration and/or damage.
- Water damage was noted on the baseboards in the front living room near the entrance door. The damaged material should be removed and replaced and the cause for the damage further evaluated and repaired to prevent additional deterioration and/or damage.
- Exterior paint deteriorated and/or dilapidated in several areas; recommend repainting.

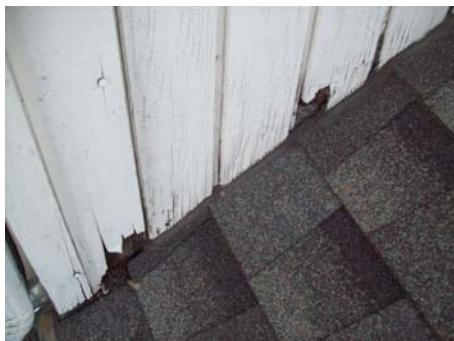
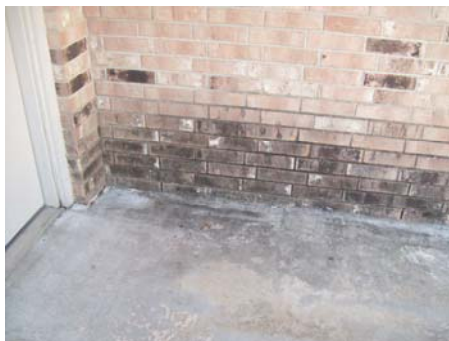
- Typical minor cracking was observed on the exterior walls of the house, including by the upstairs front balcony. This implies that some structural movement of the building has occurred, as is typical of most houses.
- Observed damage, likely caused by moisture, to siding and trim in a number of areas, including but not limited to the wood siding and trim under the front windows, along the right side of the house, on the back next to the roof, and under the master bathroom window. Moisture damage to siding and trim typically can not be repaired without replacement; however, proper sealing, painting can prevent future deterioration.

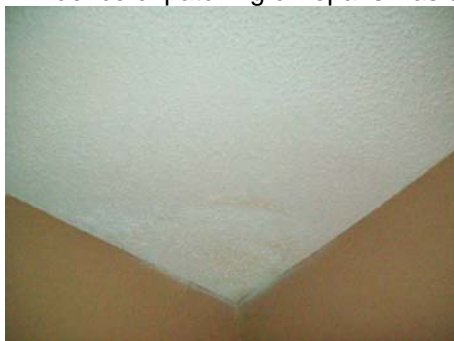
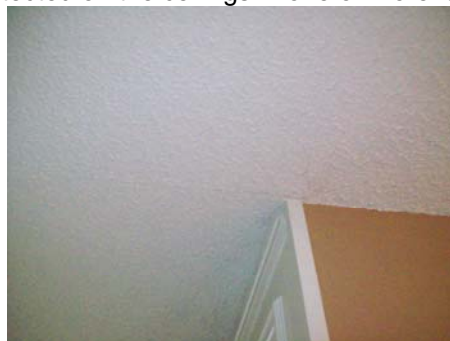
- Water staining was noted on the ceiling. The cause for the staining should be further investigated and repairs undertaken, if necessary, to prevent structural damage.
- Evidence of patching or repairs was detected on the ceilings in one or more locations.

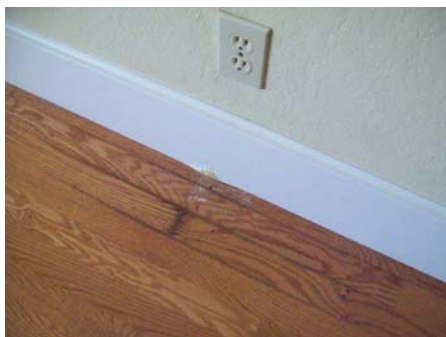
- Observed some water stains and slightly elevated moisture level on the floor in the front living room. This appears to be related to the water stain on the baseboard. Recommend further review and, if necessary, repair.

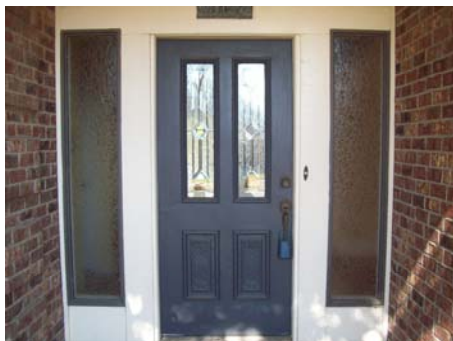
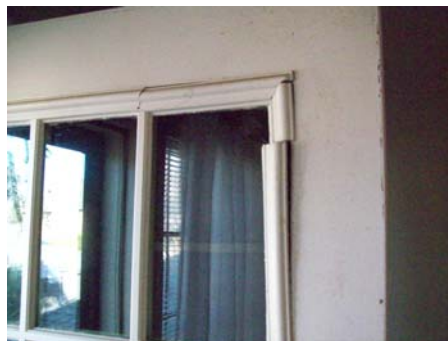
- Front door hardware is loose; recommend changing the locks upon taking possession and tightening the hardware.
- One or more doors bind and do not close properly including the door from the laundry room to the kitchen areas.
- The upstairs balcony door does not open properly, possibly due to new carpet, but the problem should be addressed to allow the door to operate properly.
- Observed some damage to the exterior of the door from the right balcony. Damaged or non-functional doors should be repaired.
- One or more door will not latch when closed, examples include the upstairs bathroom door; minor adjustment may address this problem.

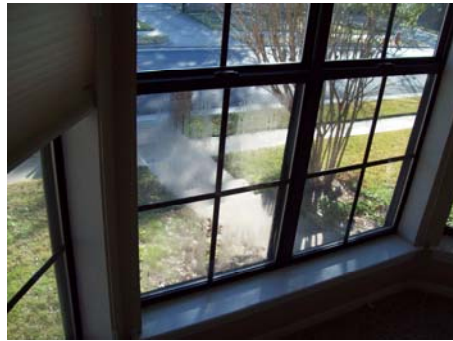
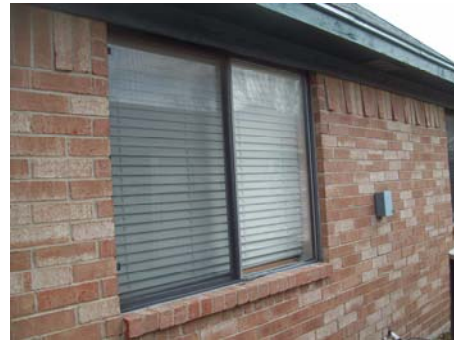
- Several windows appear to have lost their seal, examples include. This has resulted in condensation developing between the panes of glass and can cause the glass to lose its insulating properties. The glass should be repaired or replaced.
- Some of the windows show evidence of condensation. This is not a major concern. Controlling indoor humidity levels and/or improving window efficiency (if needed) would help to control this condition.
- Screens were observed to be missing on one or more of the windows; recommend replacing.

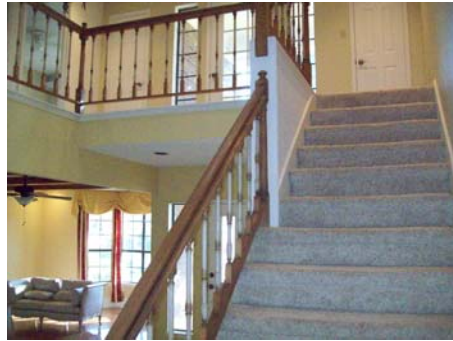
- The stairwell balusters and/or spindles are installed to far apart. Under current building standards the required guardrails on open sides of stairways, raised floor areas, balconies and porches should have intermediate rails or ornamental closures which do not allow passage of an object more than 4-inches
- The railing / guards for the stairway is loose and should be better secured for reasons of safety.

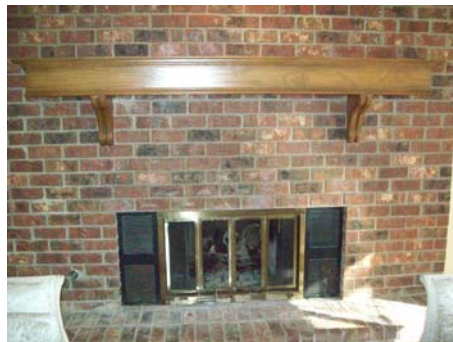
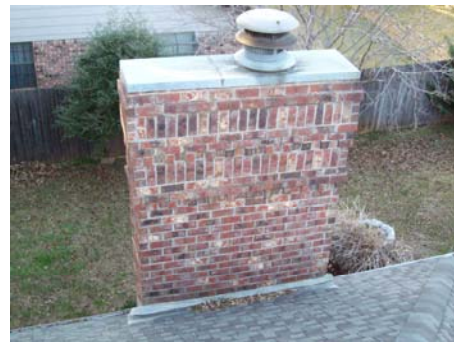
- Damper clamp or block is missing from the damper in the front living room. A damper clamp is now standard whenever gas logs are installed. This device keeps the damper from closing completely to allow any excess gas to escape up the flue. Recommend replacing.
- Chimney crickets (or saddles) are missing from both chimneys, this helps divert water around a wider chimney and is now standard when the chimney is 30 inches or wider.

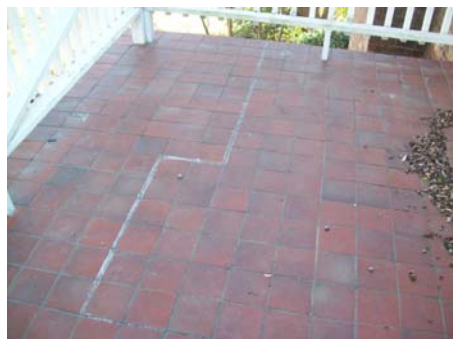
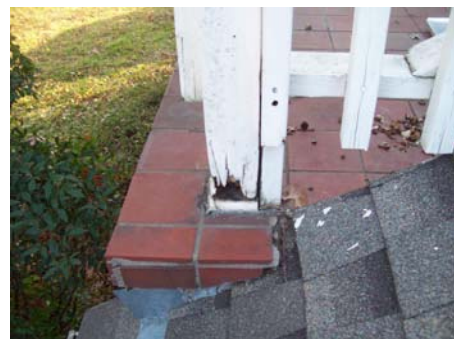
- The floor of the upstairs right balcony is cracked, this may lead to water penetration and may be the source of water for the wet area in the dining room. Recommend further review and repair.
- The railing around the upstairs right balcony is damaged and or deteriorated; recommend repair for safety reasons.

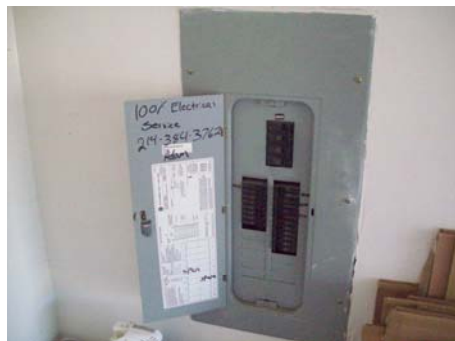
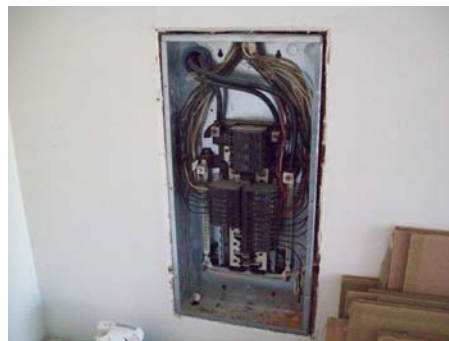
- There is incomplete labeling of the breakers in the box. Recommend having this corrected.
- Observed opening / missing punch outs in the panel cover or dead front. Any openings in the main panel should be covered.

- Cable clamp missing on the bottom right circuit. Cable clamps (sometimes referred to as bushings or grommets) are required where wiring passes into the main distribution panel. Cable clamps serve to protect the wiring from the metal edges of the panel openings.

- Neutral and ground wires are not connected on a circuit at the bottom right; recommend repair.
- Consider adding AFCI breakers (Arc Fault Circuit Interrupters), although not required when the home was built they provides some additional fire protection and are now standard on breakers throughout the house under the 2008 electrical and residential building codes. This item is required to be identified as a deficiency by TREC.

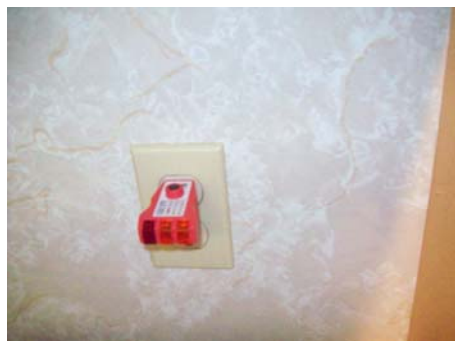
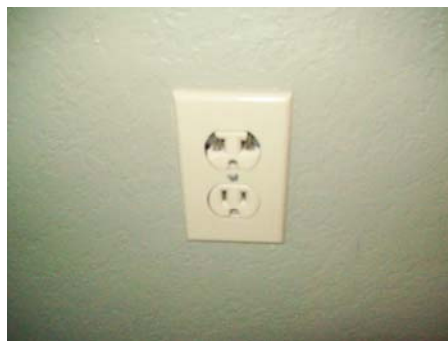
- GFCI protection is missing. Although not required when the home was built, the installation of ground fault circuit interrupters (GFCI) is recommended. GFCI protection is standards in the kitchen, bathrooms, garage, and exterior. A ground fault circuit interrupter (GFCI) offers protection from shock or electrocution.
- Missing outlet cover plates, including in the upstairs bedroom should be replaced.
- One or more outlets are inoperative, including the top one beside the ovens. Recommend repair.
- Observed one or more damaged outlets, examples include upstairs right bedroom. Damaged outlets should be replaced.
- Exterior weather cover for the outlet at the front is loose and should be repaired.
- Smoke detectors are missing from some areas. Current standards require smoke detectors in each bedroom as well as in the hall outside the bedroom; recommend installing.

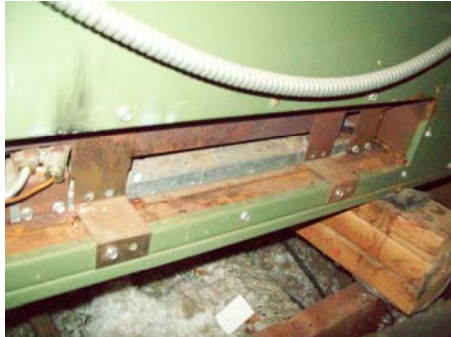
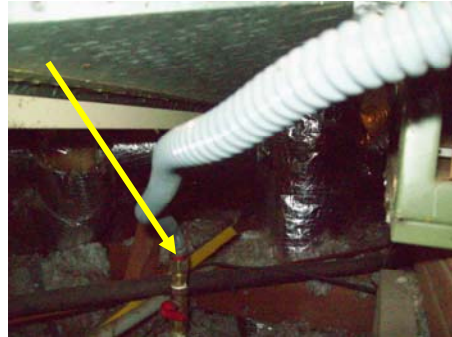
- A gas leak was detected in the furnace gas line by the shut off valve for the furnace closets to the access door. *This should be repaired immediately as it poses a safety concern.* Recommend full review of both units by licensed heating technician.

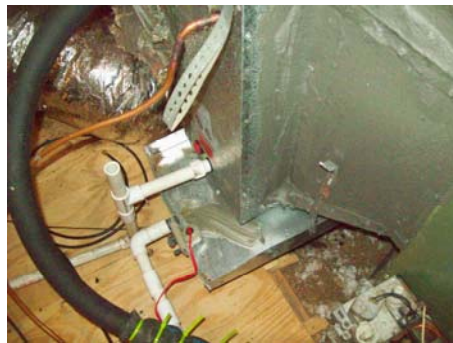
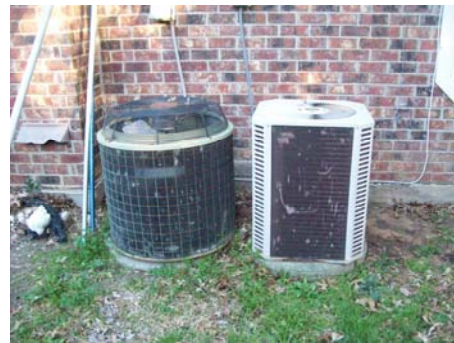
- The outdoor units of the air conditioning system are dirty, this restricts the air flow and the efficiency of the system; recommend cleaning and servicing of both systems by licensed heating and cooling technician.
- In times of high humidity, it is possible for condensation to collect on and drip off the condensate lines located in the attic; consider insulating them.

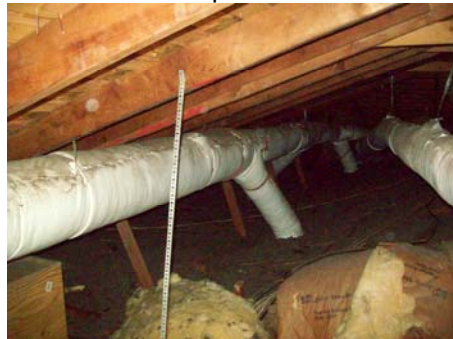
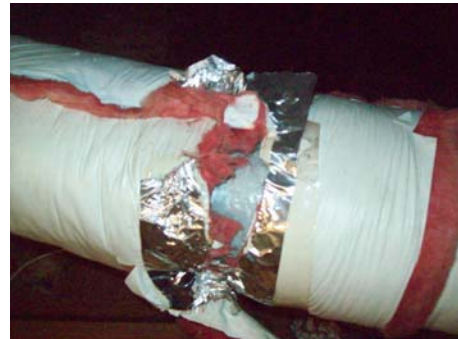
- There are some small gaps in the insulation around the ducts in the attic, including at the access where the ladder appears to rub against the duct insulation. Recommend repair.
- There does not appear to be any filters on the heating or cooling system; recommend further review repair.

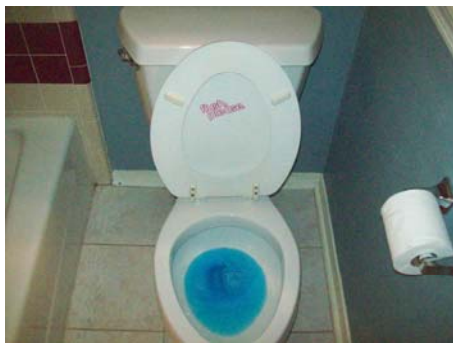
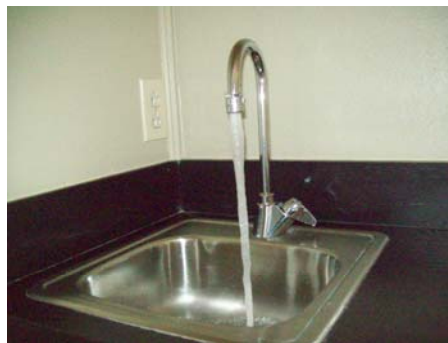
- The toilet in the hall bathroom is loose and should be re-secured.
- Observed some cracking at the corner of the tub surround in the hall bathroom; recommend recaulking to prevent water damage.
- Although it was not required when the home was built, it is recommended that an anti-siphon device be added to the exterior hose bibs.

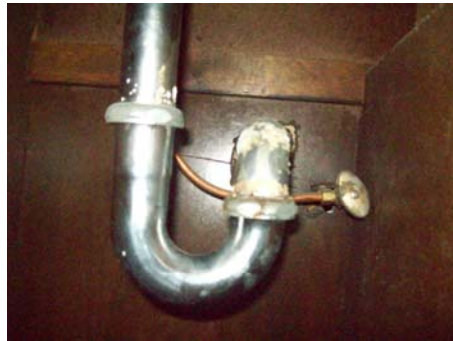
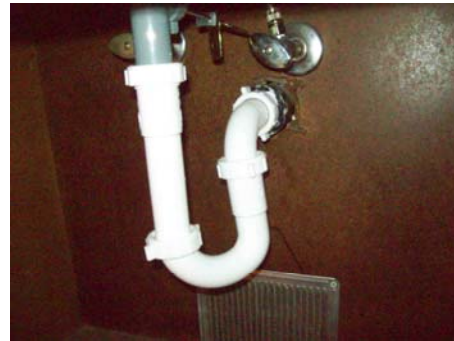
- A strong sewer odor was detected in the master bathroom. This usually suggests that the fixture is not properly vented, or that the trap has dried out. Keeping the trap primed usually addresses the problem but this area should be monitored. If odor persists, a plumber should be contacted for further review and repair.
- There is a small leak under the sink in the kitchen, recommend repair.

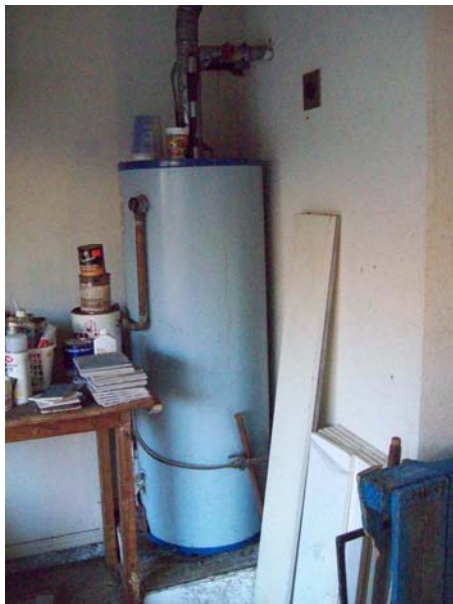
- No safety pan and drain was found for the water heater. Although it may not have been required when the home was built this should be repaired by the installation of a pan with a drain by a qualified professional
- The supply piping shows evidence of corrosion at the shut off valves and where it meets the water heater, possibly from a missing dielectric union. This is a common condition but should be repaired.

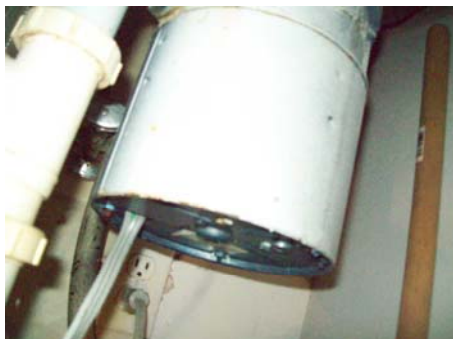
- The collar bracket for the electrical cord on the garbage disposal is missing; collar bracket for the electrical cord protects the wire from rubbing against the side of the unit and should be replaced.
- Observed a leak around the food waste disposer; recommend repair.

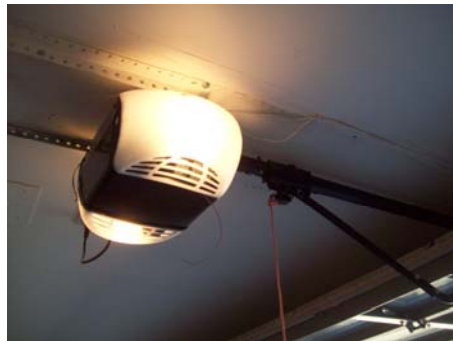
- The garage door opener did not automatically reverse under resistance to closing, the auto-reverse is missing or not working properly. *There is a risk of injury under this condition.* Recommend repair.

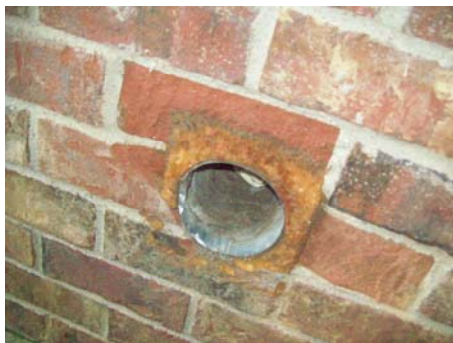
- The exterior cover over the dryer vent is missing, because this leaves the vent open to birds and rodents the cover should be replaced.

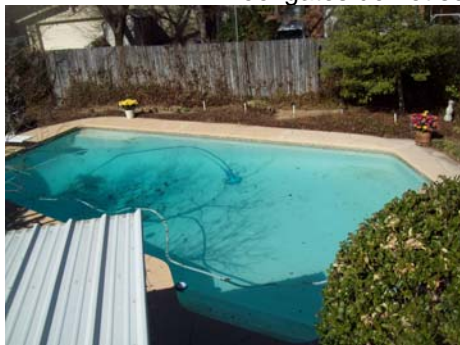
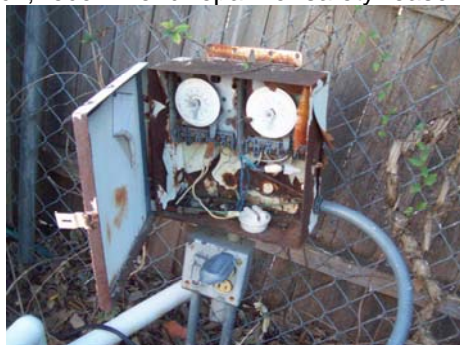
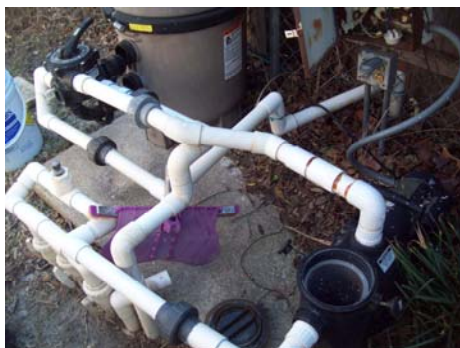
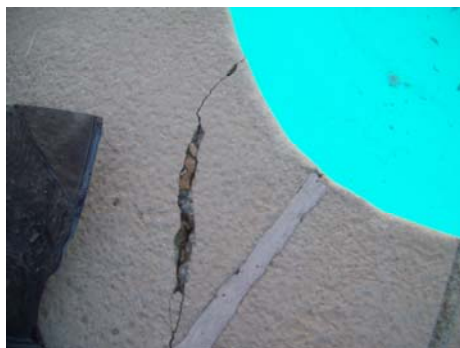
- Several tiles are missing from around the top edge of the pool; recommend replacing.
- Observed some cracks in the pool deck and areas where the coping needs some maintenance.
- The GFCI (Ground Fault Circuit Interrupter) does not test properly and should be replaced.
- Timers and box are rusted and will probably need to be replaced.
- Pool light switch does not appear to be functioning, the light could not be tested, recommend repair of the switch and retesting the light.
- The main pool drain does not meet current safety standards; recommend replacing with proper anti-siphon / anti-vortex type.
- Pool gates do not self close and latch; recommend repair for safety reasons.
