## PROPERTY INSPECTION REPORT

**Concerning:** 100 Myhome Drive, Beautiful, Texas  
(Address or Other Identification of Inspected Property)

**By:** Steven R. Cook, TREC 8713 2-1-2009  
(Name and License Number of Inspector) (Date)

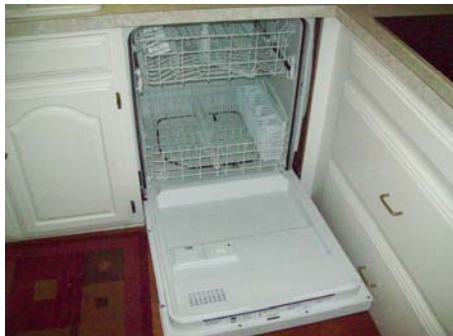
- Dishwasher was tested by running through a normal cycle; functioned normally.

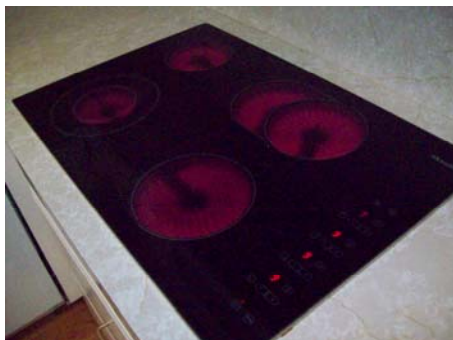
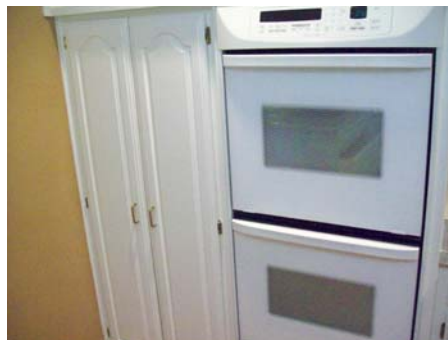
Type: Electric Cooktop and electric double oven

- Cooktop elements tested on low, medium, and high; functioned normally.
- Oven tested and working on both bake and broil.

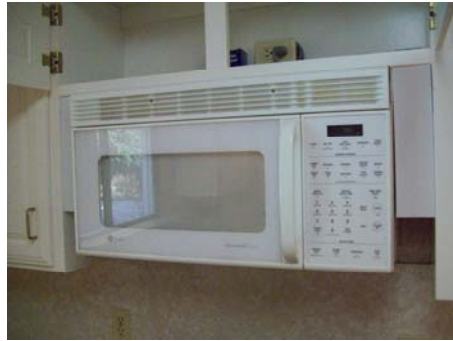
- The microwave was tested by heating a cup of water; it functioned normally.

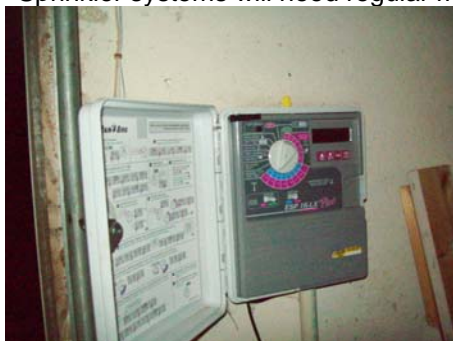
- The sprinkler system was operated in manual / test mode only. There are approximately 12 zones.
- Sprinkler systems will need regular maintenance in order to continue to function properly.
